Serious Accident Investigation Report

North Stansbury Fire

Two Lightning Strike Fatalities

August 23, 2000

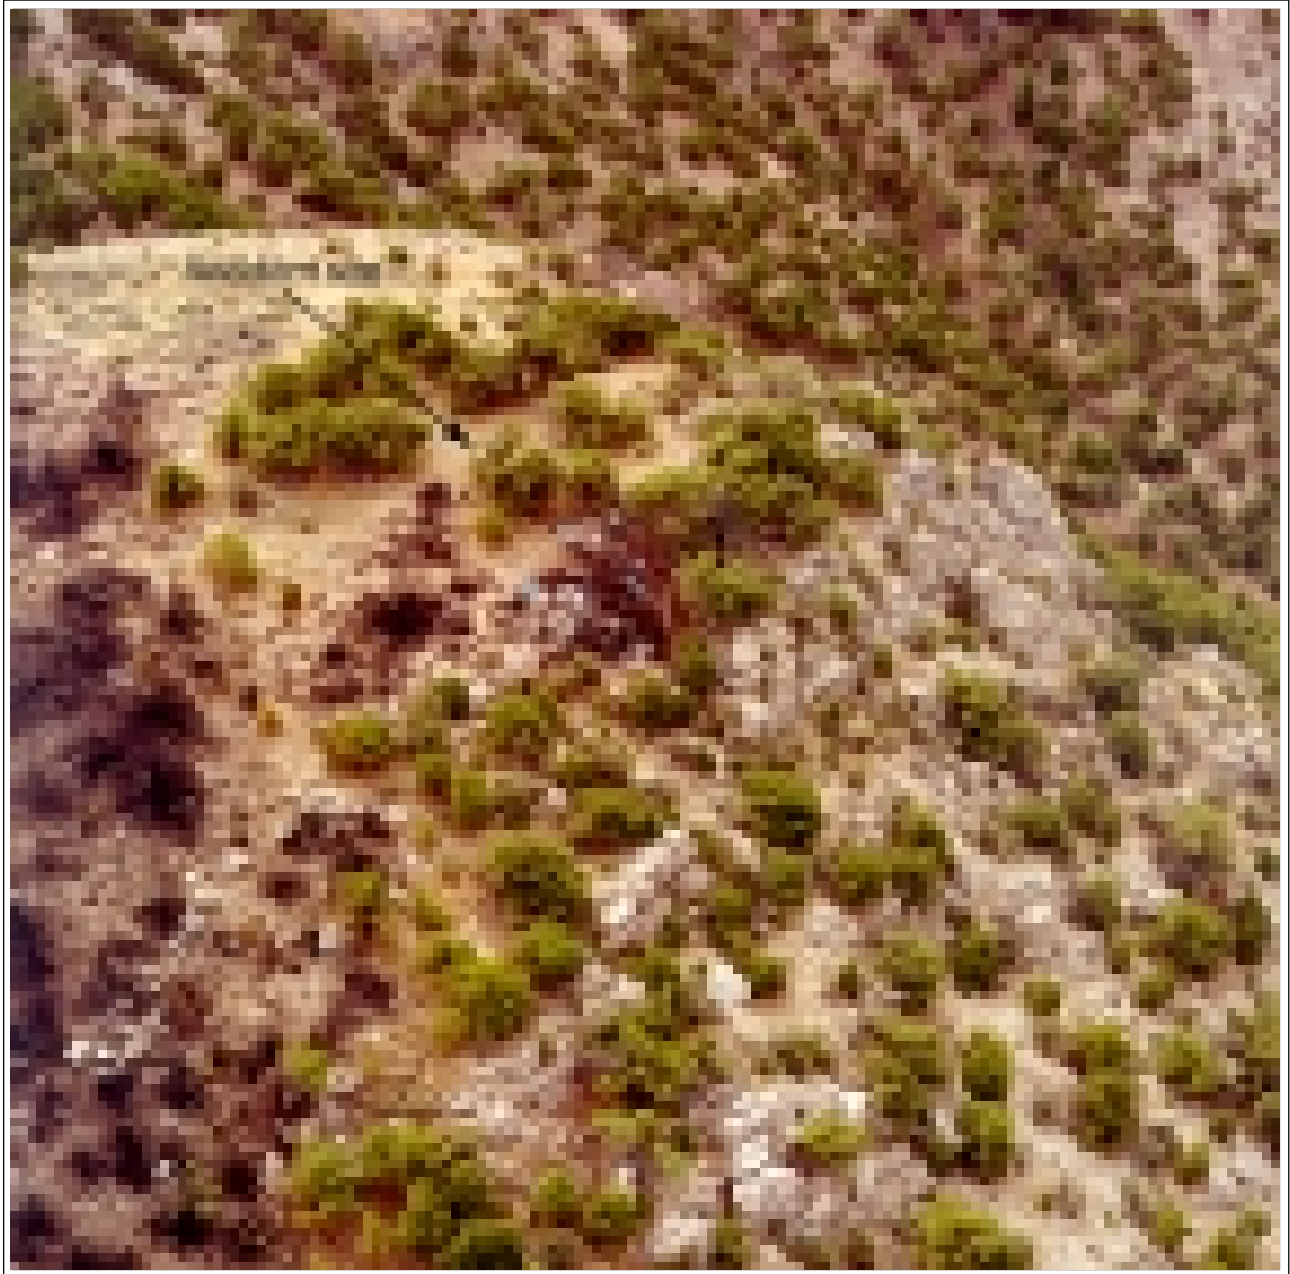
Photo 2. Aerial view of accident site.

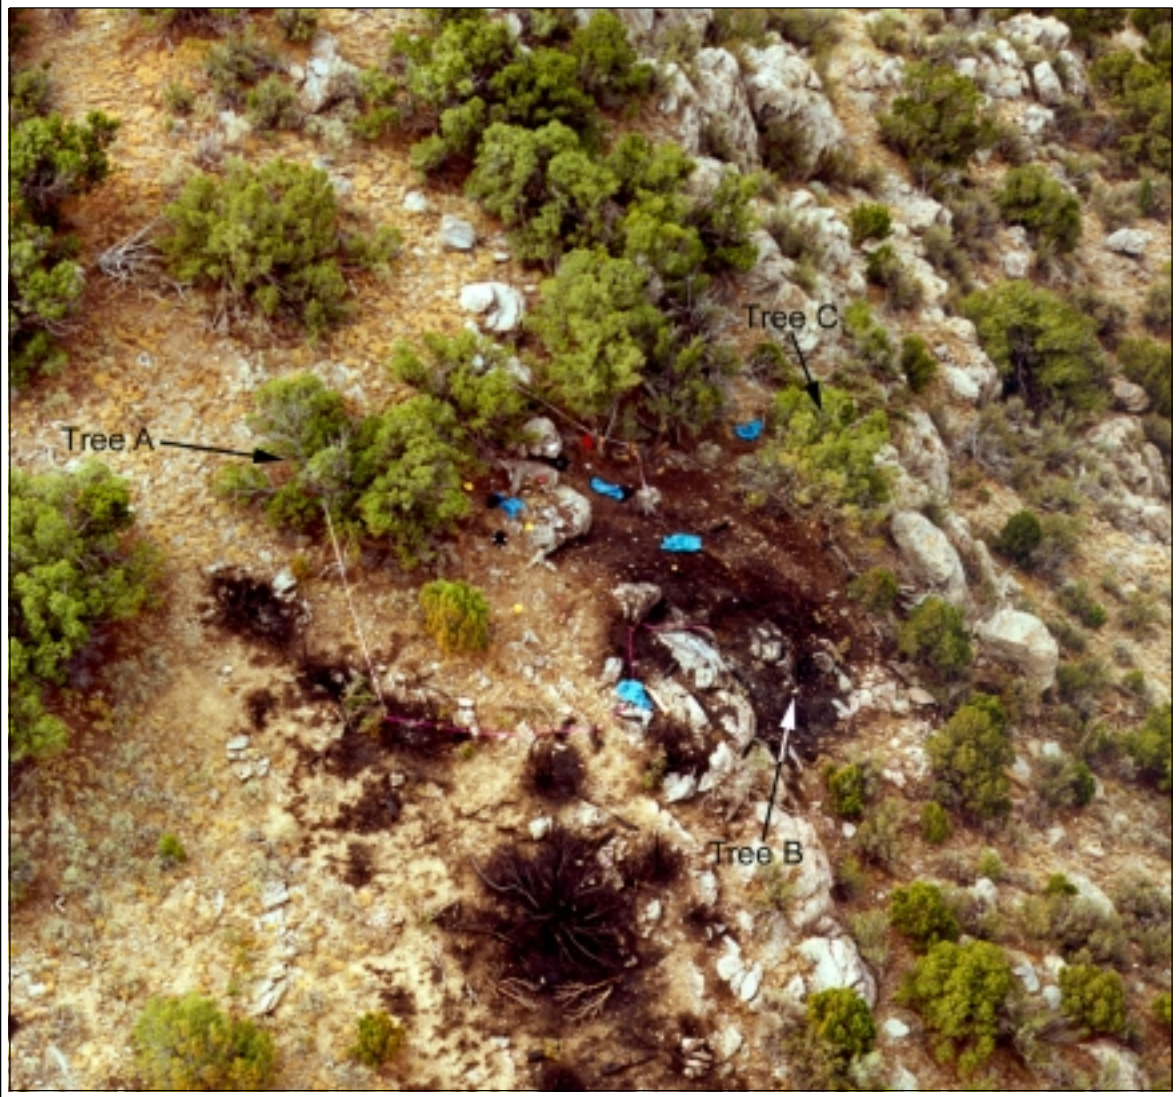
Photo 3. Locations of lightning strike trees.

Three recent lightning scars were found at the site of the accident. One scar was on the tree nearest Braithwaite, Tree A, the other two 23 feet and 54 feet away (Trees B and C, sketch of site, appendix 6). Tree A had a light coating of recent retardant. The lightning strike to Tree A removed retardant coated material, thus was subsequent to the retardant drop three days before (20 August). The terminus of the strike to Tree A was in a crevice within 2 feet of Braithwaite’s pack at the base of the tree on the West side near the pen on photo 3-1. The scars are shown on photos 3-2 and 3-3, including the last scar on the tree near the base to the right of the pen on photo 3-3. Tree B had burned in the fire, and the scar on that tree was clearly after the burn (photo 3-4). The terminus of the strike to Tree B was on a rock at the base of the tree, five to seven inches from the tree (photo 3-5). The terminus of the strike to Tree C was not found, but fresh scars were found all the way down the tree as in photo 3-6. No fresh scars were found on other trees within 100 m of the site, although old scars were evident.

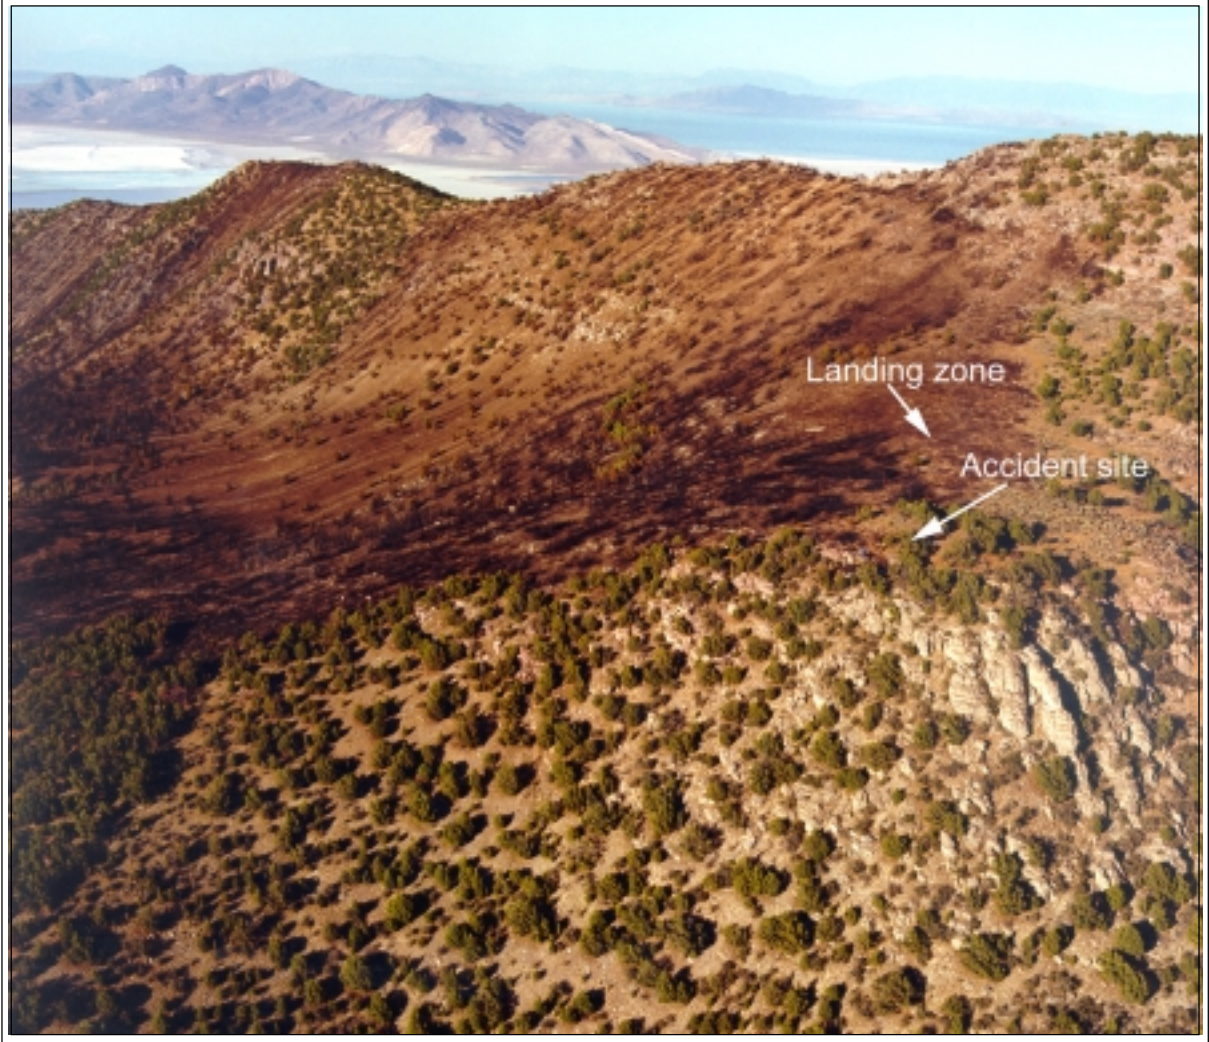
Initial visits by SAIT members indicated that the crew members were located on a relatively flat area at the edge of the fire line. All had apparently covered themselves with tarps. One squad member, Braithwaite, took shelter under a juniper tree (Tree A, photograph 3). Two other squad members, Chacon and Bishop, shared a tarp near another juniper tree about 14 feet to the south. The remaining three squad members, Lindsay, Duran, and Taliulu, moved about 30 feet lower on the slope to the east below a rock outcropping (Photographs 4, 5, and 6, and Diagram 1).

Photo 4. Aerial view of accident site and landing zone.

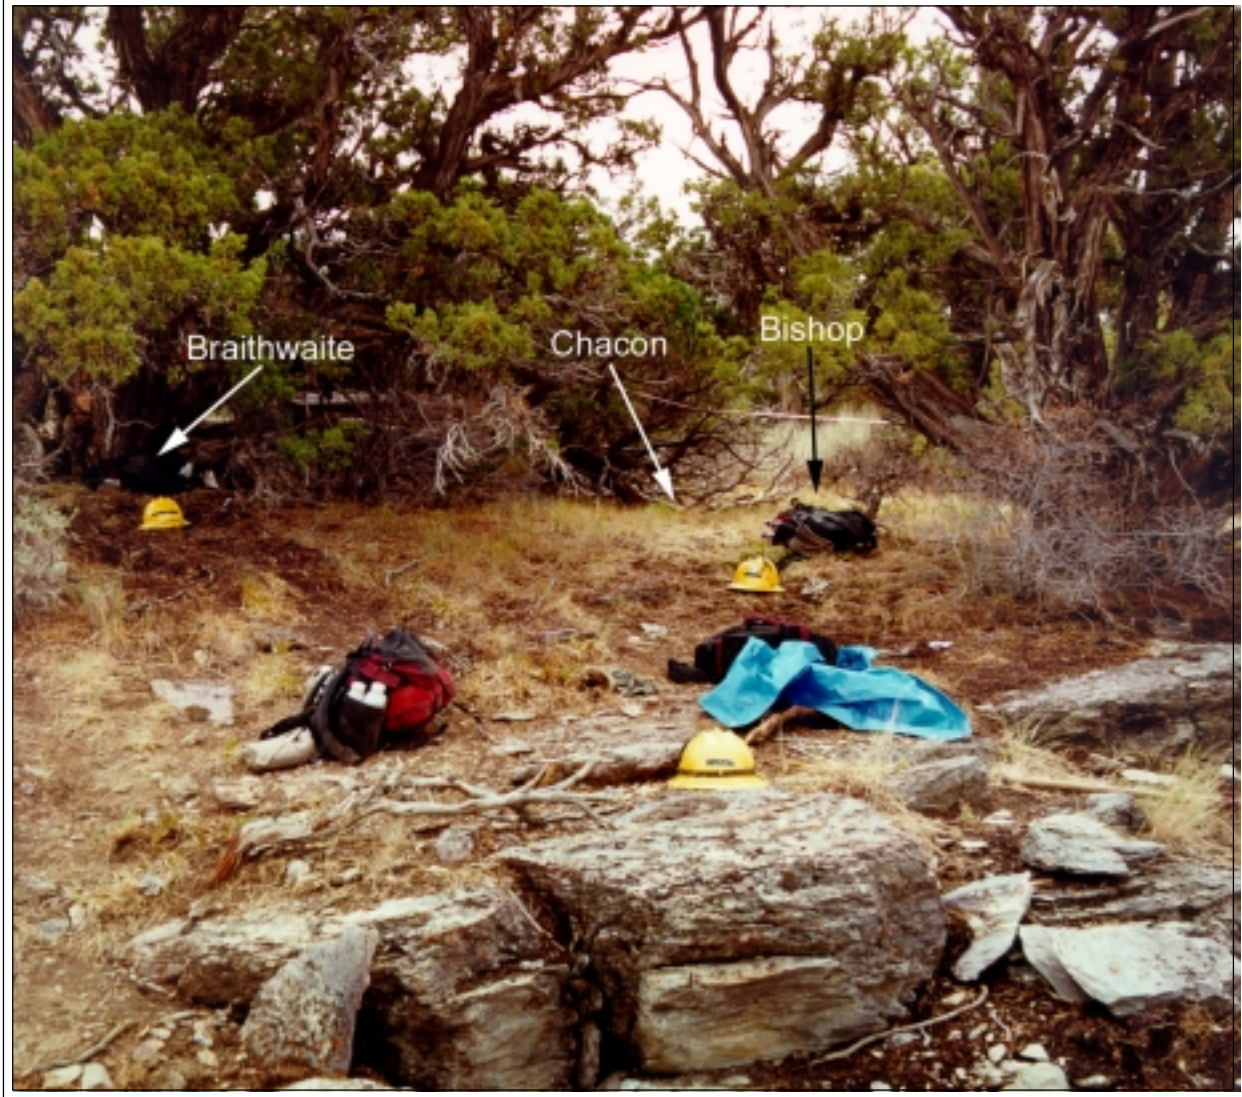
Photo 5. Fatality site.

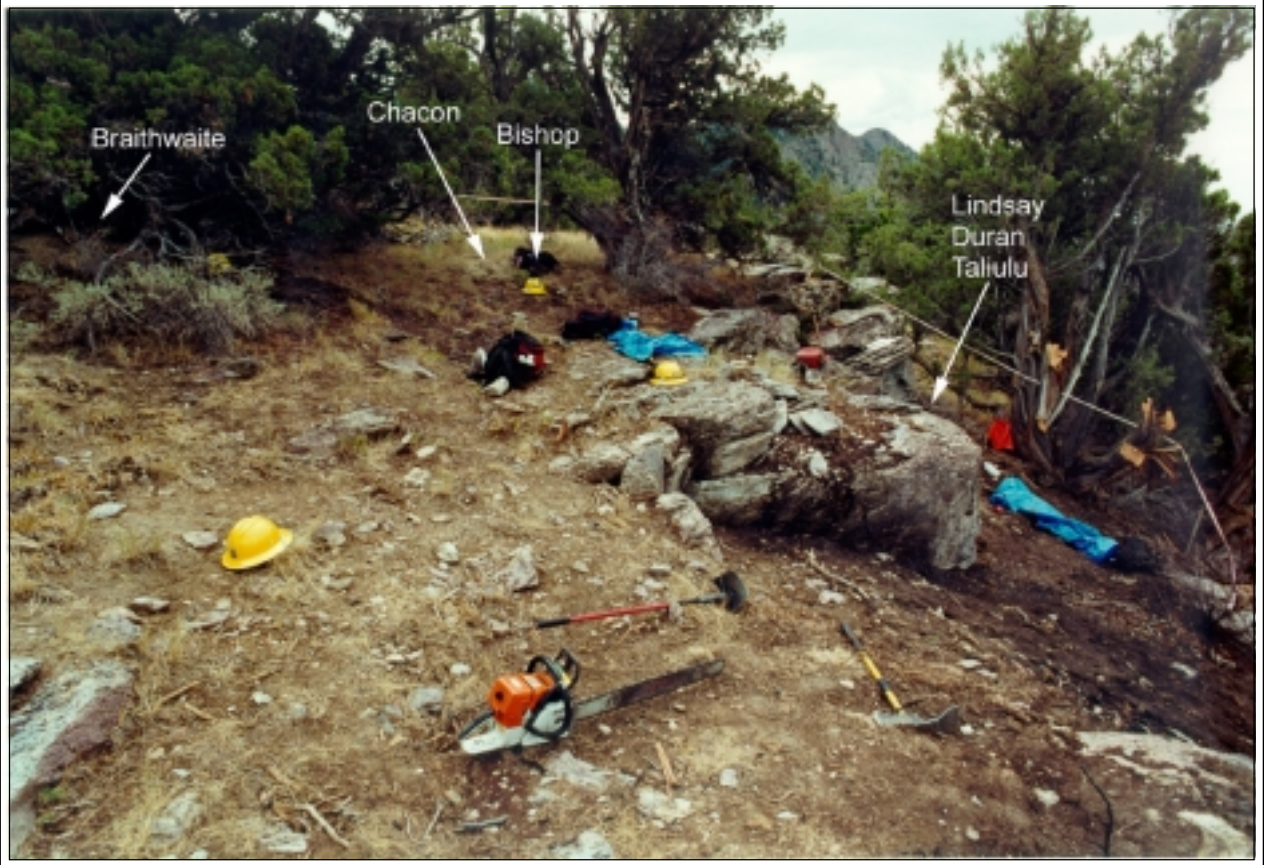
Photo 6. Locations of personnel.

It was noted during the investigation that most short squad members were sitting on their day packs. Braithwaite was laying on the ground up against his day pack which was leaning on Tree A. Lightning research indicates crew members should not lie down during thunderstorm activity and suggests that firefighters sit on their day packs with their feet together in an open area. This would minimize the area of the body in contact with the ground, thus reducing the potential to carry ground current.

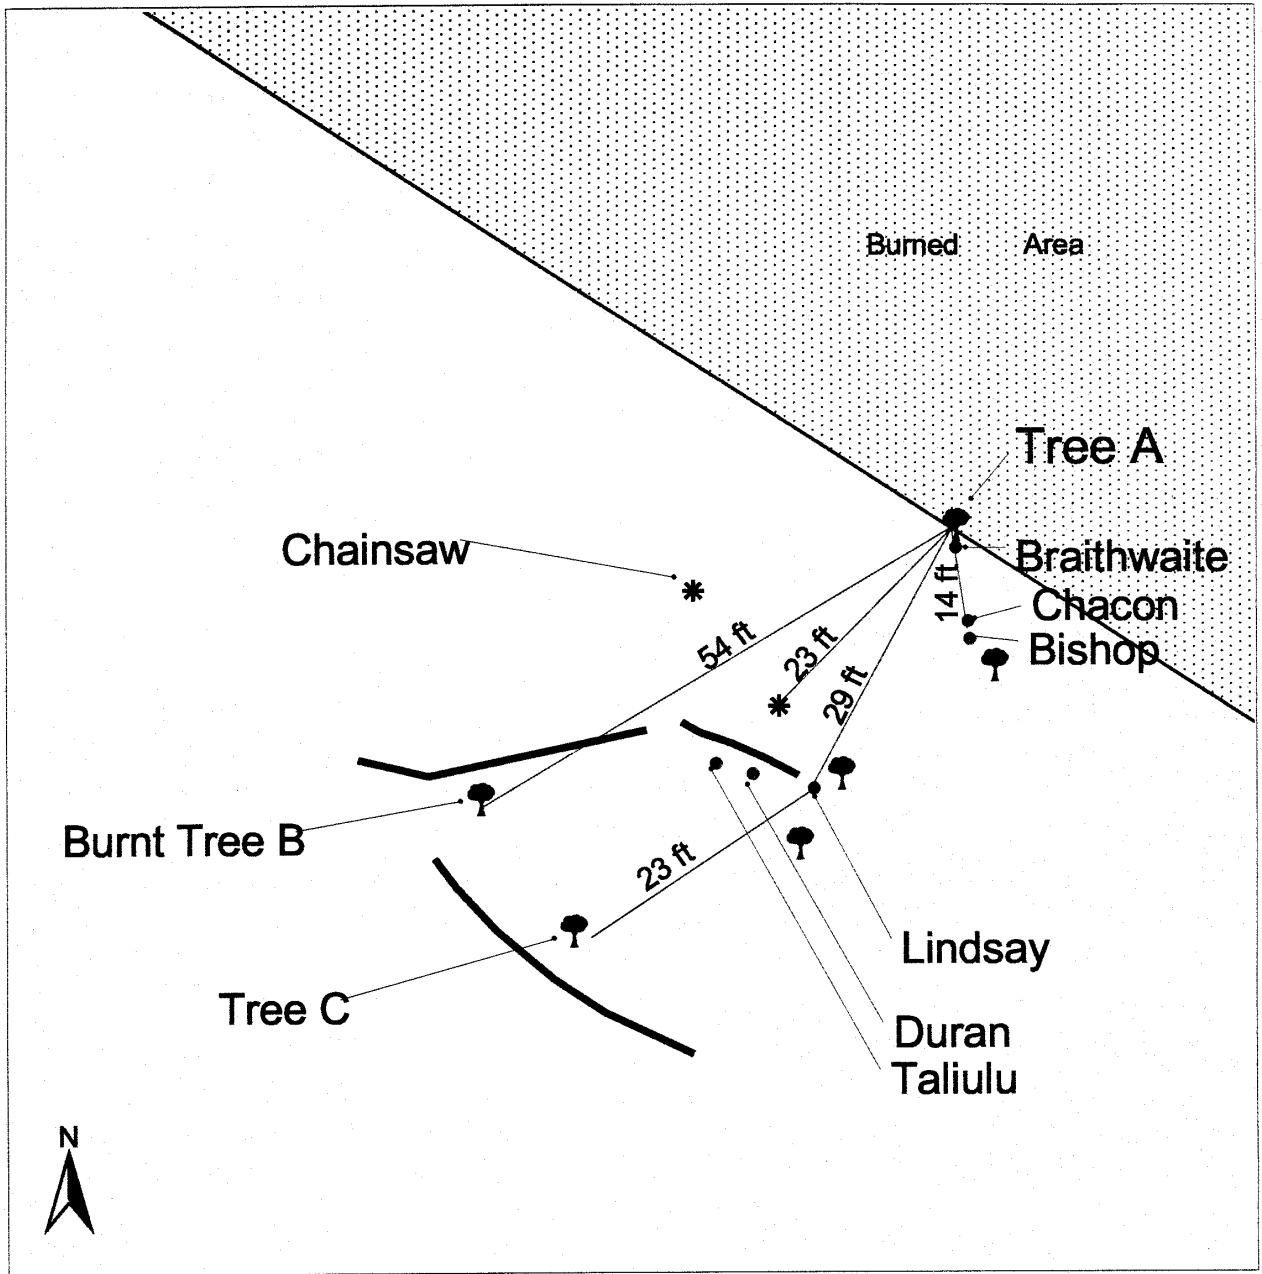
Diagram 1. Sketch of the fatality site.

SKETCH OF FATALITY SITE
NORTH STANSBURY INCIDENT
 August 23, 2000
 1200 hours

The accident was caused by a single lightning flash, #7. Both fatalities apparently resulted from one path to ground, that of tree A, from this flash. The three paths to ground, based on tree scars, were either from multiple strokes in this flash, or multiple paths to ground from one or more strokes in the flash. The most likely case is a three-stroke flash. Lightning location multiplicities, that is, the number of strokes in a given flash, from lightning location data, can be in error, as can the location. In any case, the lightning causing the accident would probably have been over within about one-half second.

The three other members of the group, Lindsay, Duran, and Tailulu were injured and dazed, probably by the discharge to tree C, possibly also from tree B, and could also have received current from tree A. The whole group of six probably intercepted currents of varying strength from all three terminus trees, but again, it was undoubtedly the current from tree A that caused the fatalities.

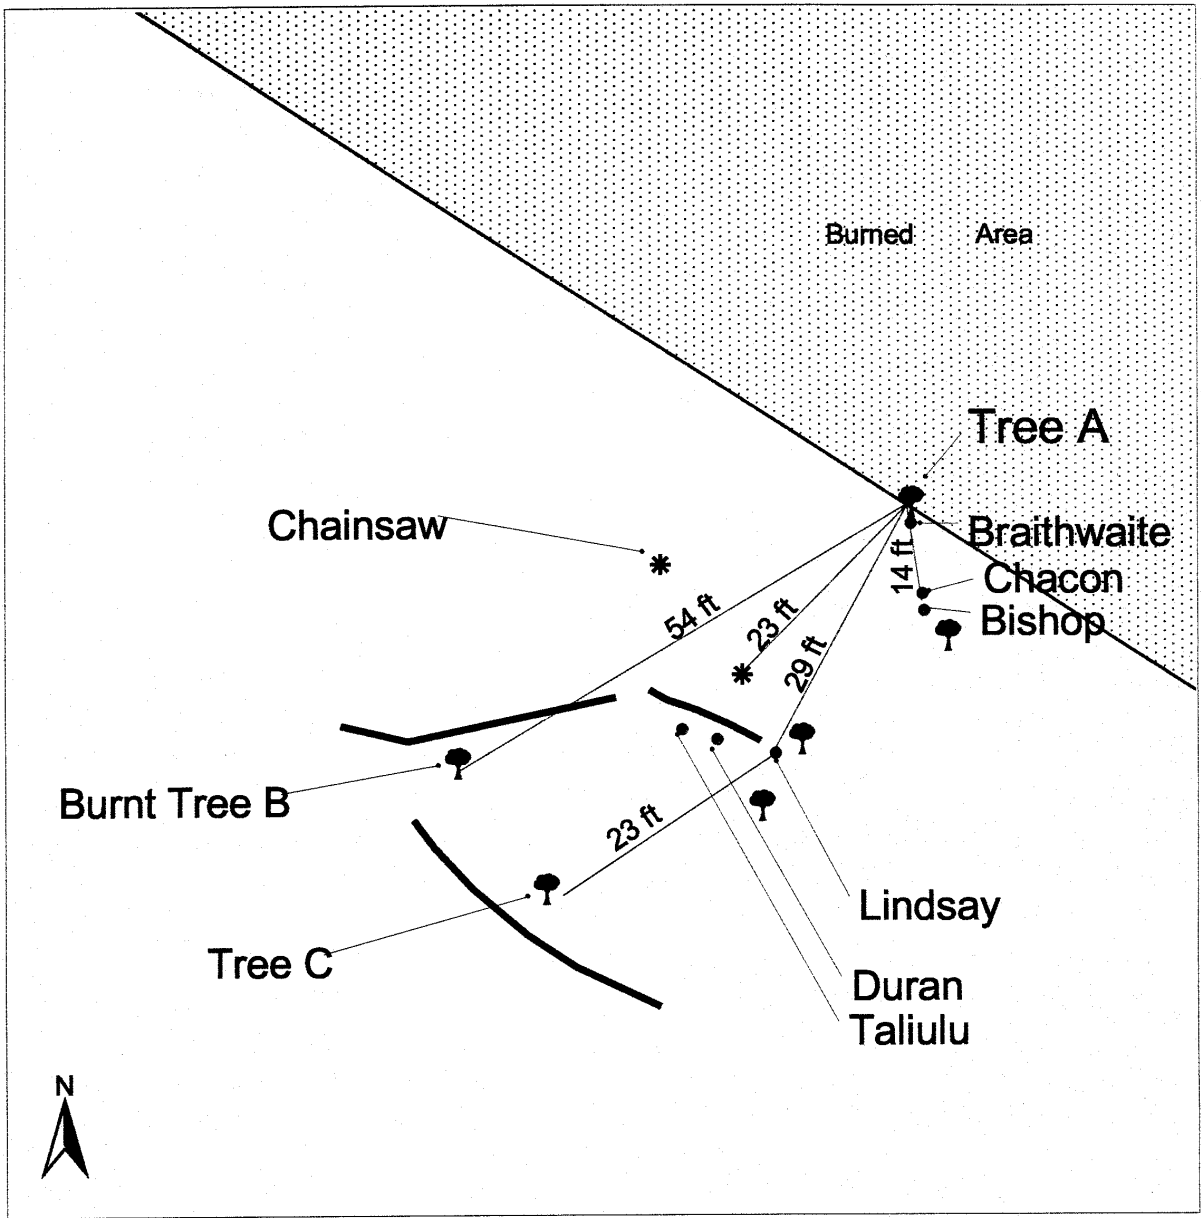
**SKETCH OF FATALITY SITE
NORTH STANSBURY INCIDENT
August 23, 2000
1200 hours**
