Serious Accident Investigation Report

North Stansbury Fire

Two Lightning Strike Fatalities

August 23, 2000

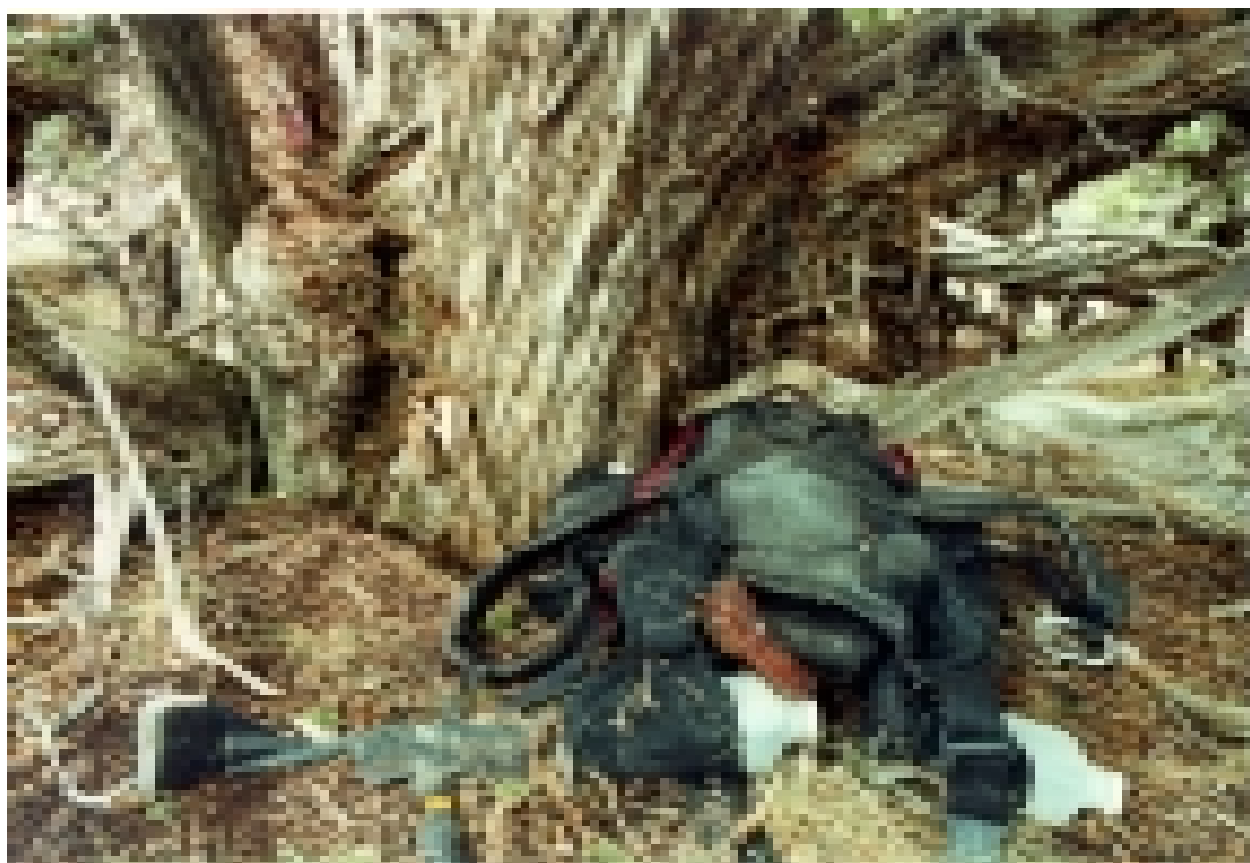
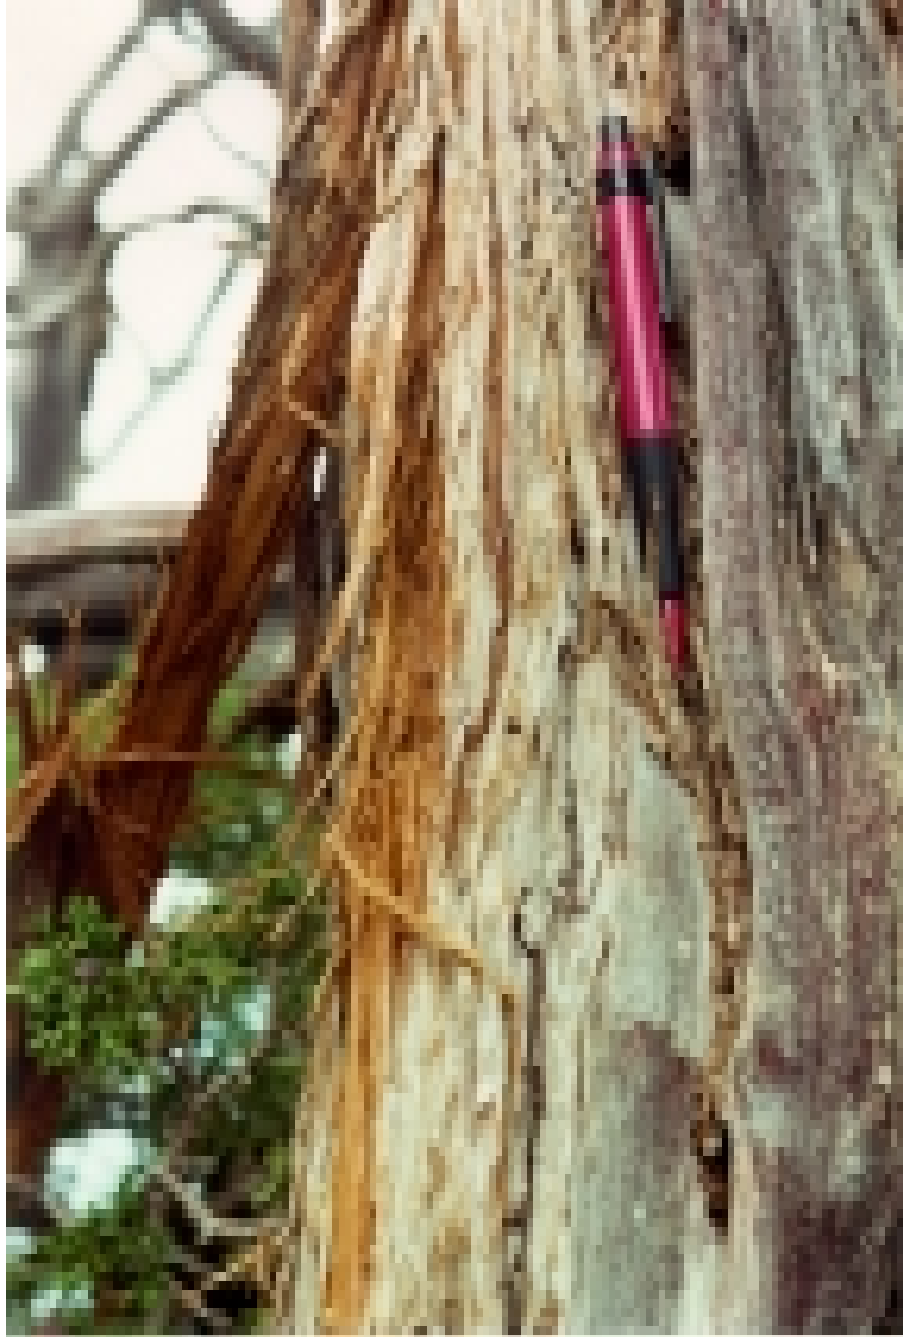
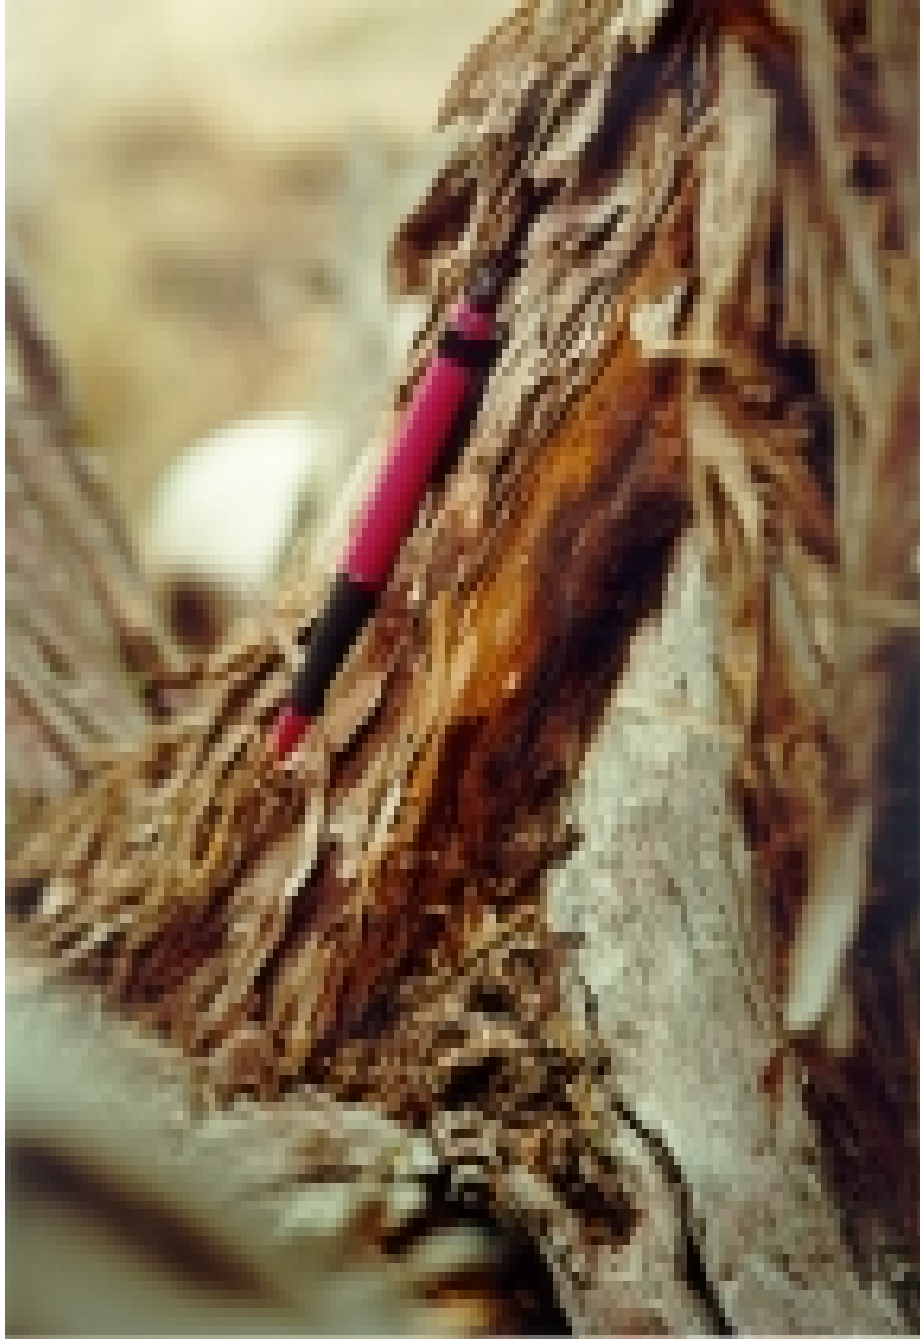
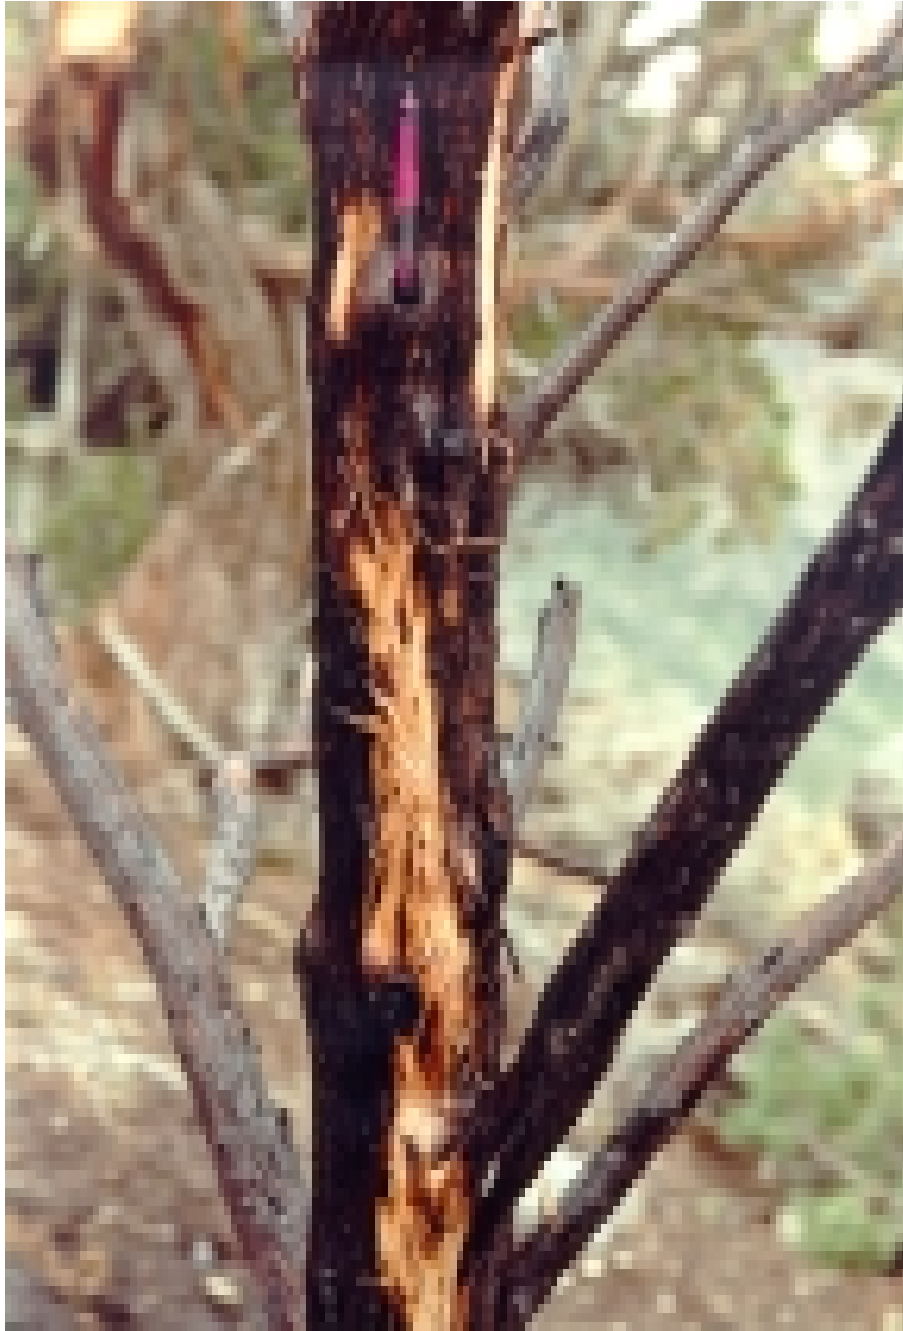
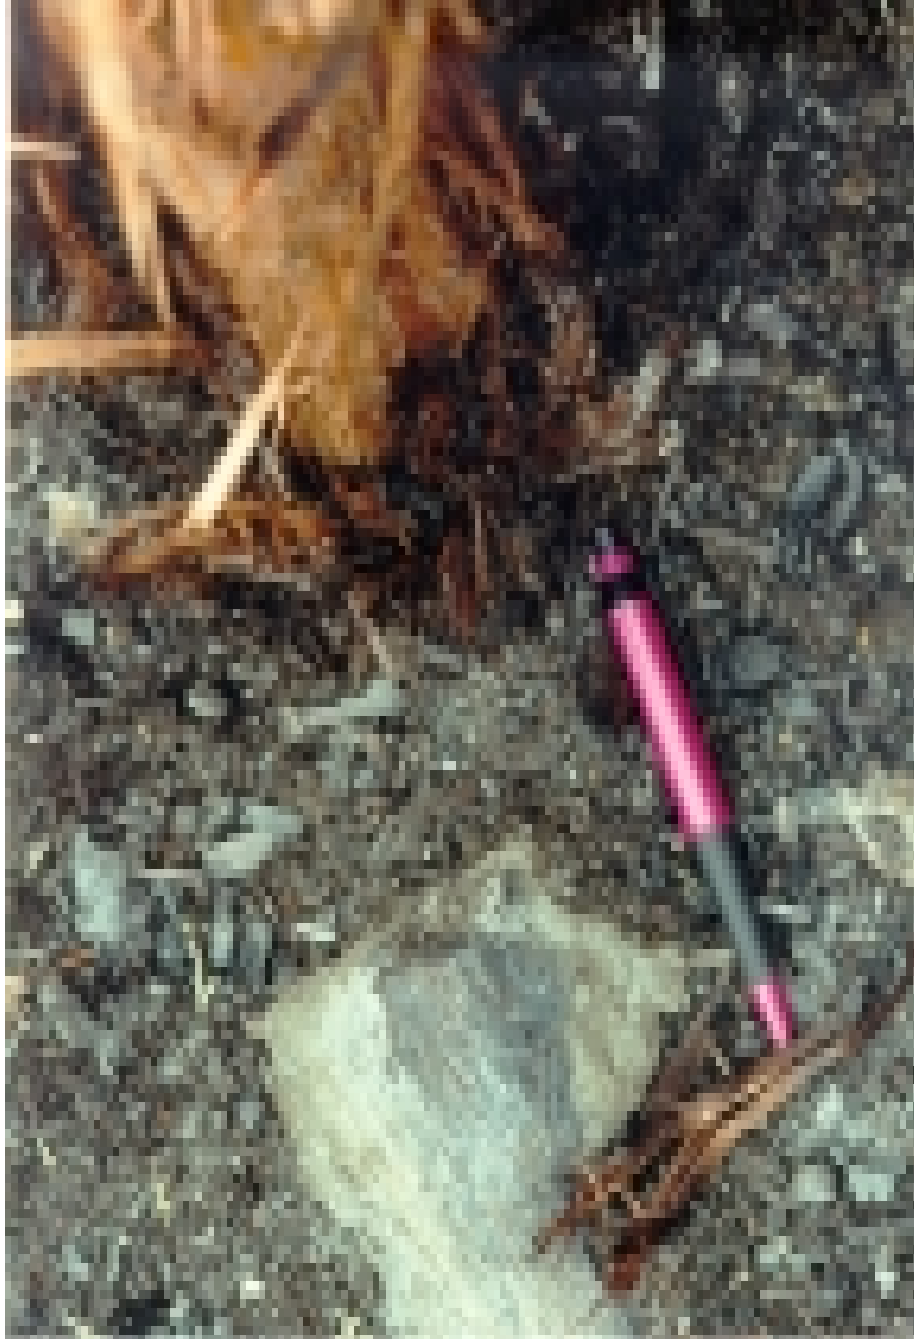
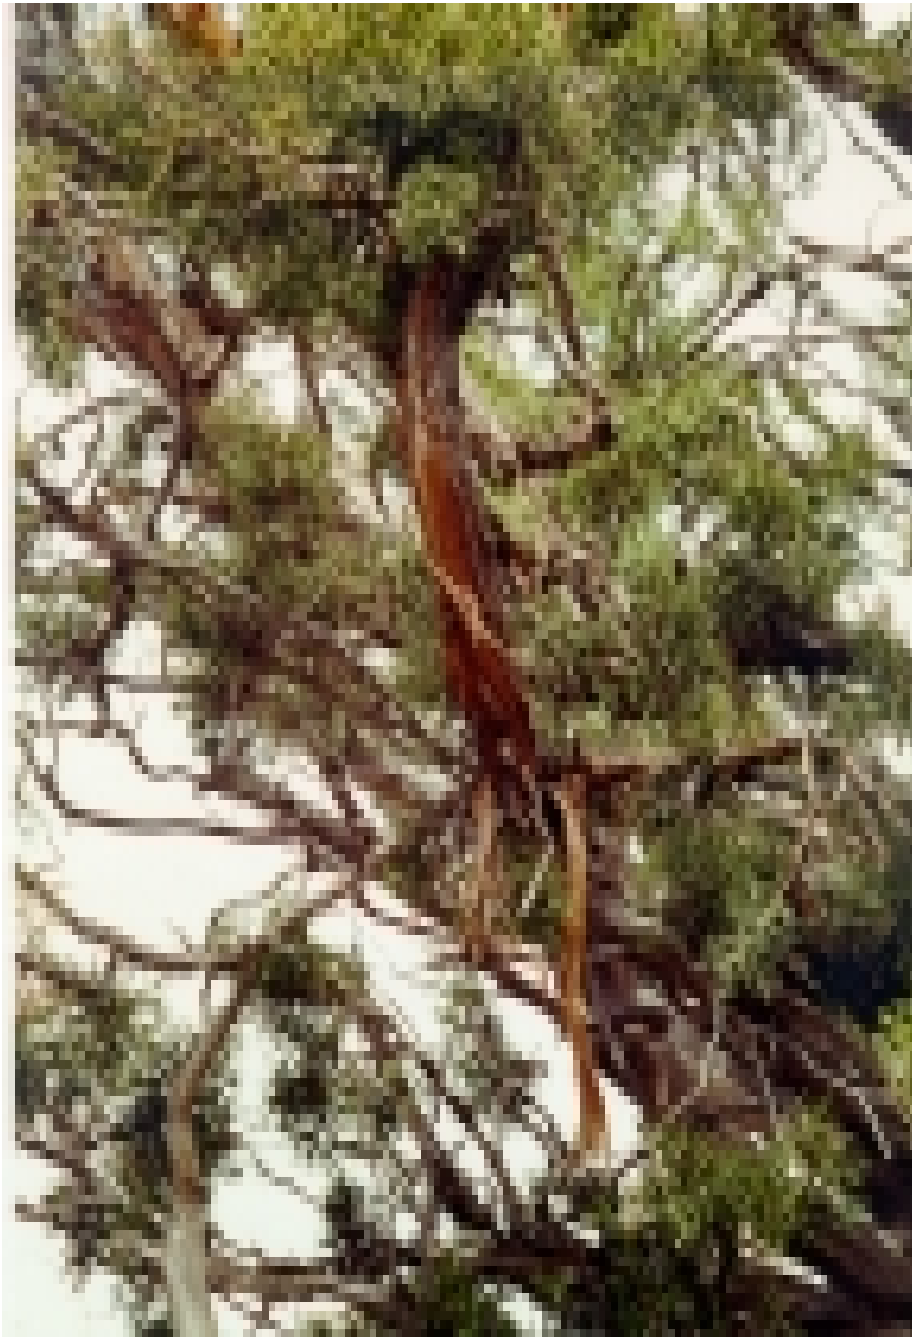
Three recent lightning scars were found at the site of the accident. One scar was on the tree nearest Braithwaite, Tree A, the other two 23 feet and 54 feet away (Trees B and C, sketch of site, appendix 6). Tree A had a light coating of recent retardant. The lightning strike to Tree A removed retardant coated material, thus was subsequent to the retardant drop three days before (20 August). The terminus of the strike to Tree A was in a crevice within 2 feet of Braithwaite’s pack at the base of the tree on the West side near the pen on photo 3-1. The scars are shown on photos 3-2 and 3-3, including the last scar on the tree near the base to the right of the pen on photo 3-3. Tree B had burned in the fire, and the scar on that tree was clearly after the burn (photo 3-4). The terminus of the strike to Tree B was on a rock at the base of the tree, five to seven inches from the tree (photo 3-5). The terminus of the strike to Tree C was not found, but fresh scars were found all the way down the tree as in photo 3-6. No fresh scars were found on other trees within 100 m of the site, although old scars were evident.
